Emergency responder and public health considerations for plastic sewer lining chemical waste exposures in indoor environments

To appear in: *Journal of Hazardous Materials*

Keywords: Sewer repair; Plumbing; Vapor intrusion; Styrene; Volatile chemical products; Building ventilation

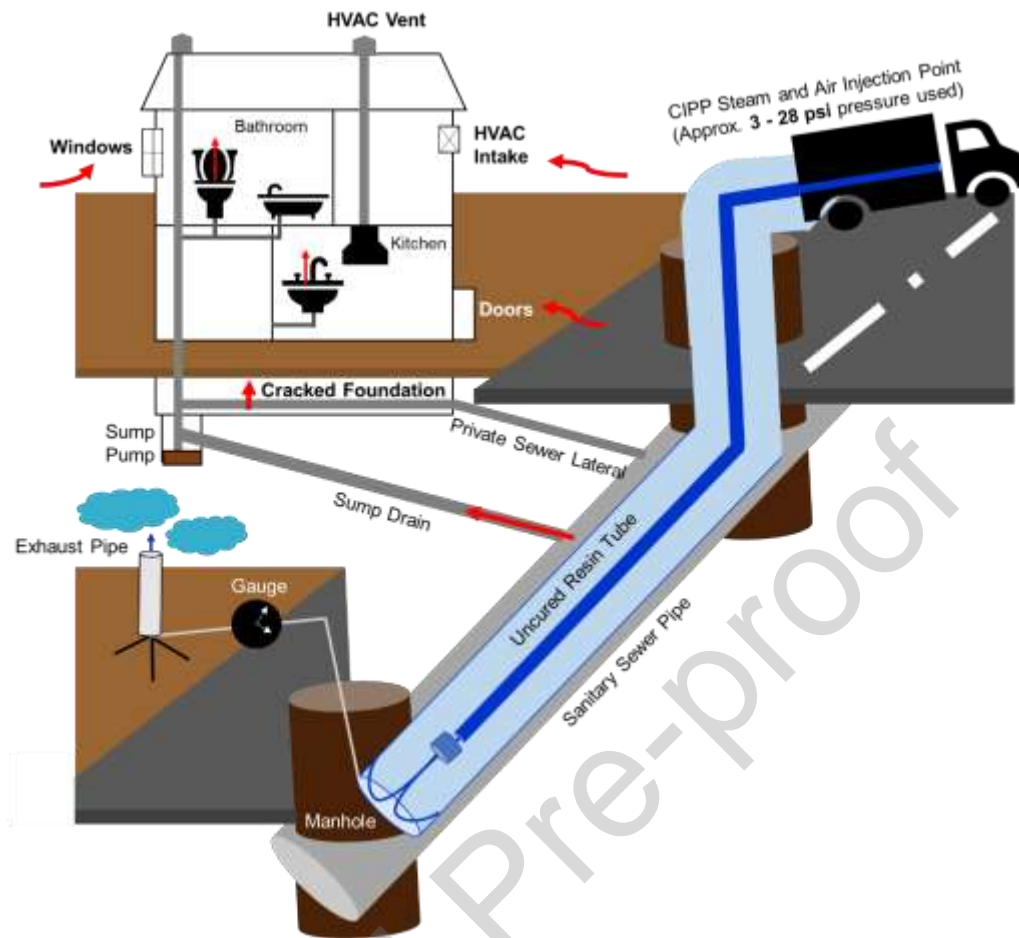
Figure 1. Schematic of building intrusion pathways for CIPP waste products from a sewer liner manufacturing worksite. The CIPP worksite includes a pressure source at the truck, uncured resin tube, exhaust pipe, and the escape of exhaust and fugitive emissions into the air.

CIPP waste can enter buildings through multiple pathways (Figure 1). Waste material can be discharged into the air during the uncured resin tube insertion, curing, and cool-down processes. Waste can travel through sewer pipes directly to buildings, enter the building through foundation cracks, and exit the buried pipes through manholes and vents aboveground. Water seal blowback incidents for sinks and toilets have been reported, and sometimes buildings next to one another did not have the same indoor air contamination problems. This may be because of differences in sewer pipe characteristics (i.e., size, cracks,

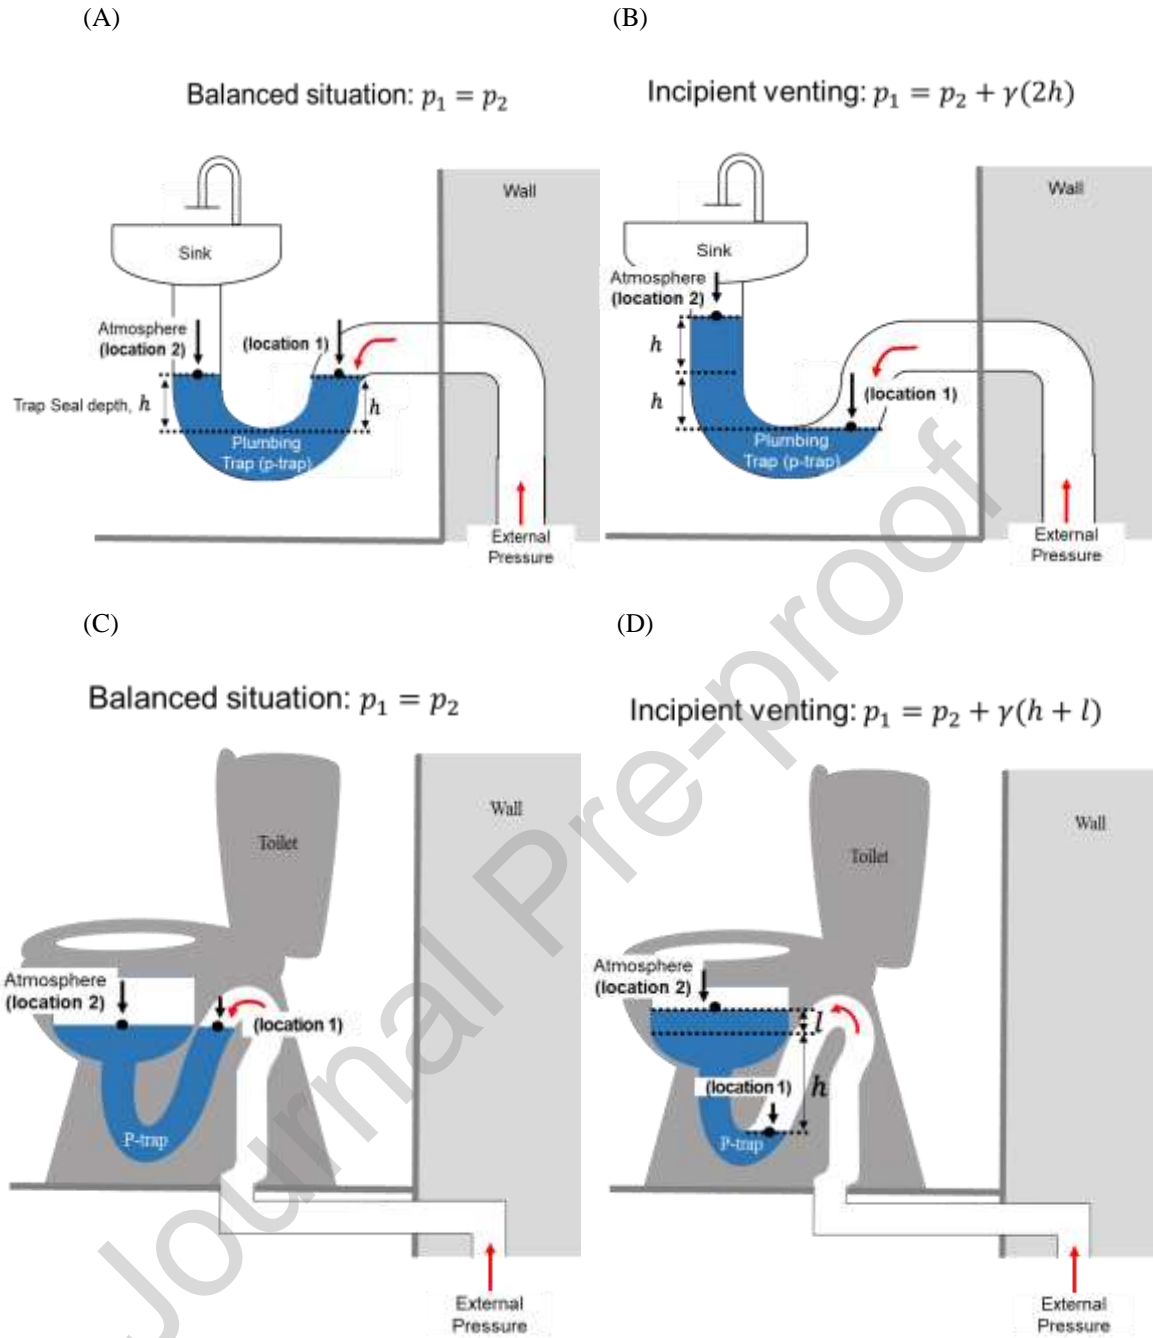
Figure 2. A sectional view of the sink (A, B) and toilet (C, D) in a typical bathroom.

To estimate the air pressure needed for water seal displacement, the dimensions of a standard sink p-trap in the U.S. were applied (Ripka, 1997). The sink drain is connected to a p-trap and then runs to the wall (Figure 2A, 2B). The trap depth is considered to range between $h = 5.08$ and 10.16 cm (about 2 and 4 in) (International Code Council, 2019; International association of Plumbing and mechanical officials, 2018). The relative (gauge) pressure needed to displace the water seal was calculated by assuming a hydrostatic pressure distribution in the water at the point of incipient venting and equating the volume of water between the balanced case and the moment of incipient venting, which will occur at the point shown in Figure 2B (this was verified with a simple laboratory experiment):

The air pressure required to cause displacement of the toilet trap water seal was estimated in a similar manner to the sink (Figure 2C, 2D). As the excess sewer gas pressure pushes the trap water down, the water will rise slightly in the toilet, with the volume of water rising in the toilet balancing the water displaced from the trap seal. The authors assumed that

the point shown in Figure 2D is the point of incipient venting and that the water has a hydrostatic pressure distribution at this point. The toilet trap seal depth is usually used as $h = 10.16$ cm (about 4 in) (International Code Council, 2019; International association of Plumbing and mechanical officials, 2018), and the p-trap pipe inner area estimated at 45.58 cm² (about 3 in diameter) (Ripka, 1997; USEPA, 2015a). Equating the water volume displaced from the trap to the toilet bowl, and assuming a water surface area of 360 cm² (determined by inspection of several toilet bowls in the U.S.), the bowl water deflection is estimated as $l = \left(\frac{360}{45.58}\right)h$. With these assumptions, the necessary sewer gas back pressure (gauge) for toilet venting becomes:

For sinks, the minimum pressure needed to displace the p-trap water seal was calculated to be 0.995 kPa (about 0.14 psi). For a toilet, 8.85 kPa (about 1.28 psi) was needed for water seal displacement. These pressures were much less than the reported pressure applied by contractors during sewer lining, 20.56 to 193.05 kPa (about 3 to 28 psi). Limited publicly available information was found regarding maximum and average pressures by contractors used during lining or pressure differentials at indoor sewer plumbing fixtures. No studies were found that had previously examined external pressure-induced water seal blowback. Since head loss may occur due to fluid friction with the pipe wall and elevation,

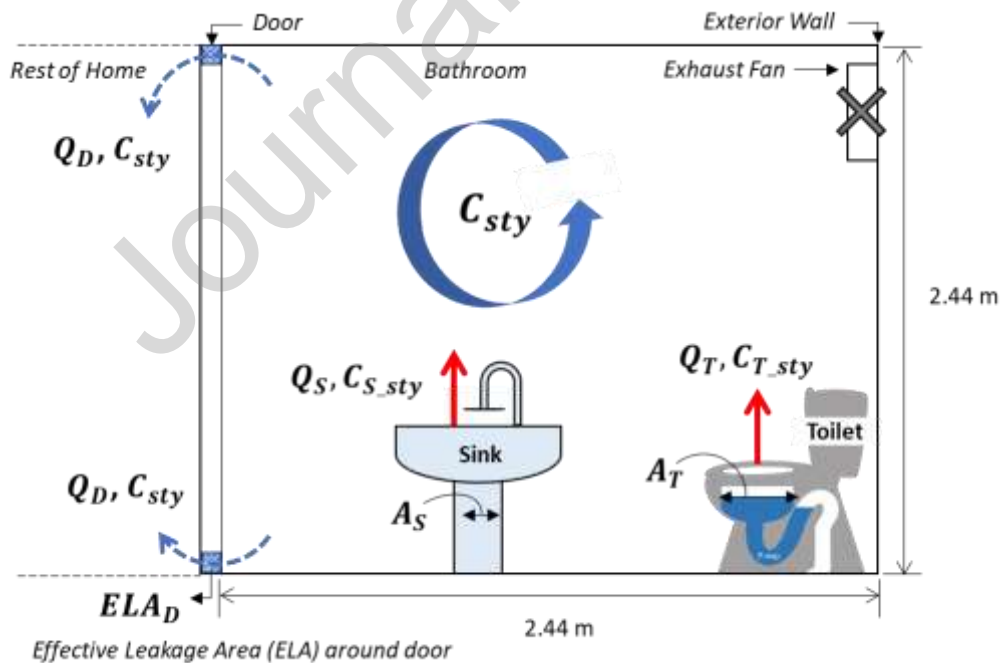
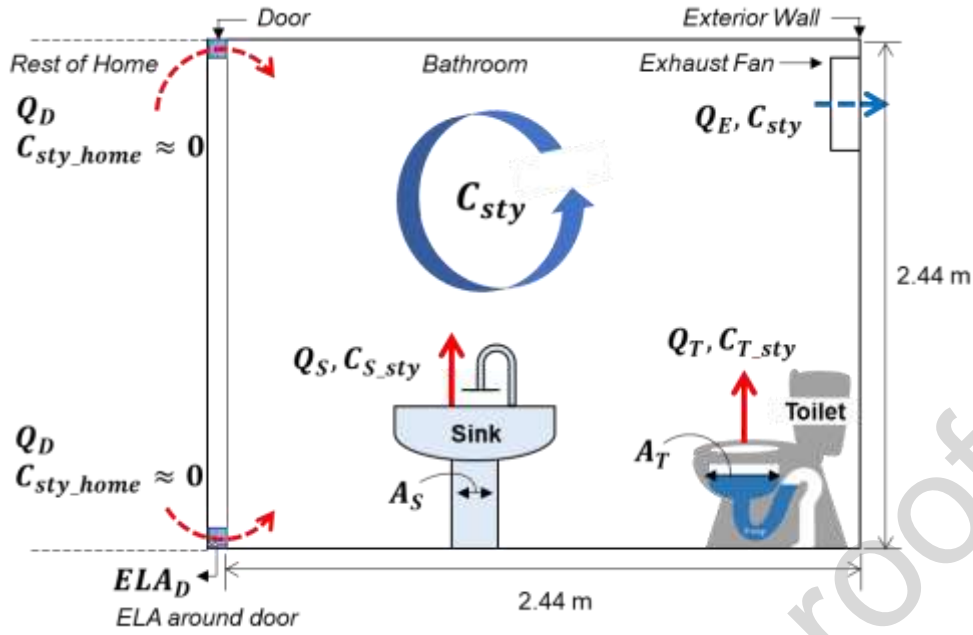
Figure 3. Schematic of bathroom model with the location of the sink, toilet, and bathroom exhaust fan noted: (A) non-ventilation condition (exhaust fan off) and (B) ventilation condition (exhaust fan on). The diagram is a single-cell CSTR model; the arrows represent the airflow pathways. Supply and return vents for a home mechanical HVAC system are not considered.

The indoor air model was limited to styrene in the bathroom only, and the vapor concentration was assumed to be significantly affected by the bathroom air exchange rate (AER, h^{-1}) (Reichman, Shirazi, et al., 2017). Indoor AERs of 0.25 and 0.50 h^{-1} are commonly used in indoor air modeling analyses (Reichman, Shirazi, et al., 2017), and the U.S. EPA suggests a typical indoor AER value of 0.18 to 1.26 h^{-1} (USEPA, 2015b). In this study, 0.5 h^{-1} was selected as the AER value for the bathroom for the non-ventilation case (exhaust fan off, infiltration across closed door) (Table 1). An effective leakage area (ELA) can exist due to small cracks or gaps around doors and windows. Since the ELA for the exterior bathroom wall is small, any air entering through the sink or toilet would leave through the door as that is the only other opening (assuming the exhaust fan damper remains shut) (Figure 3). It also assumed that the air entering the bathroom from the sink and/or toilet causes the bathroom to be positively pressurized relative to an adjacent hallway or room (Equation 4):

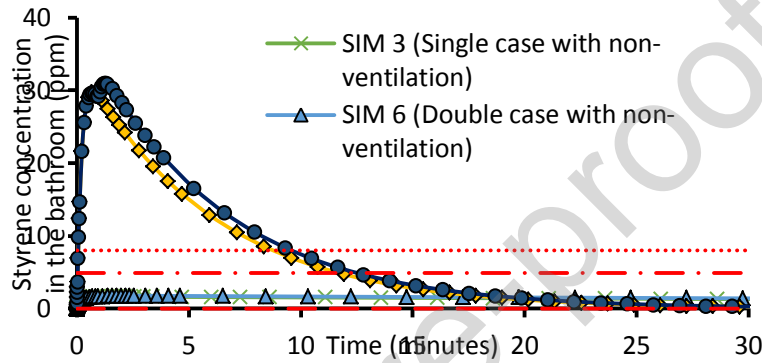
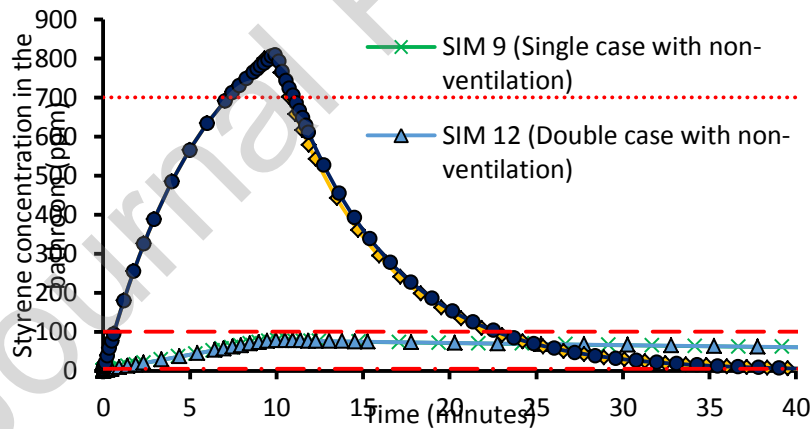
Figure 4. Time-series of the estimated indoor styrene vapor concentration after inflow ($C_{T/S_sty} = 1,000$ ppm) into the bathroom for the: (A) instantaneous inflow cases and (B) constant inflow cases. The ventilation level was simulated for a perfectly sealed door. For information on the type of styrene influx and its intrusion condition, see Table S4 and Table 1, respectively.

The predicted bathroom air styrene concentration was influenced by bathroom exhaust fan operation and certain conditions prompted exceedance of the styrene IDLH concentration. Figure 4 shows the time-dependent change in indoor styrene concentration according to the C_c emission scenario ($C_{T/S_sty} = 1,000$ ppm) from the sink and/or toilet under

perfectly sealed door condition. For both the instantaneous inflow (Figure 4A) and the 10 min constant inflow conditions (Figure 4B), the greatest styrene concentrations were found when the exhaust fan was on (AER 10 h⁻¹), followed by the non-ventilation condition (AER 0.5 h⁻¹ with a perfectly sealed door). This was due to the bathroom exhaust fan entraining more contaminated styrene-laden air through the p-trap of the sink and toilet during its operation.

When the exhaust fan was operated at a constant toilet/sink emission, styrene concentrations of 802 ppm and 806 ppm were reached in under 10 min (Figure 4B). These levels far exceeded a variety of worker exposure limits, including the OSHA ceiling limit (200 ppm) (OSHA, 2020) and NIOSH IDLH concentration (700 ppm) (NIOSH, 2020). NIOSH recommends that workers should wear an organic vapor cartridge respirator when 500 ppm styrene concentrations or higher are possible, and a self-contained breathing apparatus (SCBA) with a full face piece when levels are 700 ppm or higher (NIOSH, 2020). Once the emission ceased, the exhaust fan on scenario showed 45 min was needed for styrene levels to decrease below the AREL, and 85 min was needed to reach the odor threshold concentration. When the exhaust fan was off under the high discharge case, the maximum styrene concentration was 77 ppm. The levels also exceeded recommended occupational short-term exposure limit (STEL; 15-min); 40 ppm of ACGIH (40 ppm) (ACGIH, 1999). During a 60 min period, the total amount of styrene that passed through the bathroom, under the double discharge condition, was 625 kg (with ventilation) and 300 kg (for non-ventilation case) (Figure S4).

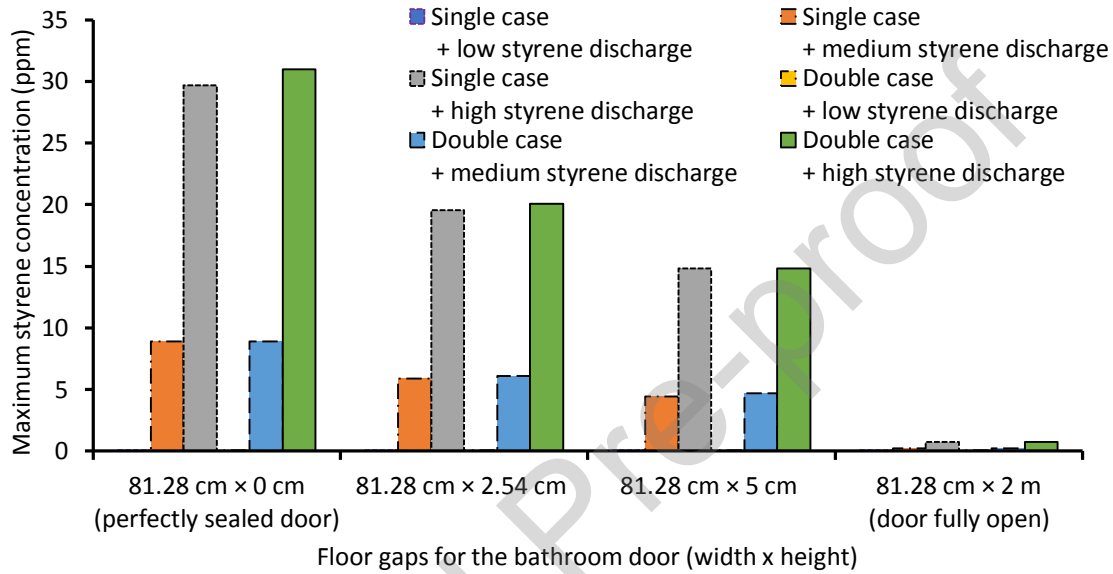
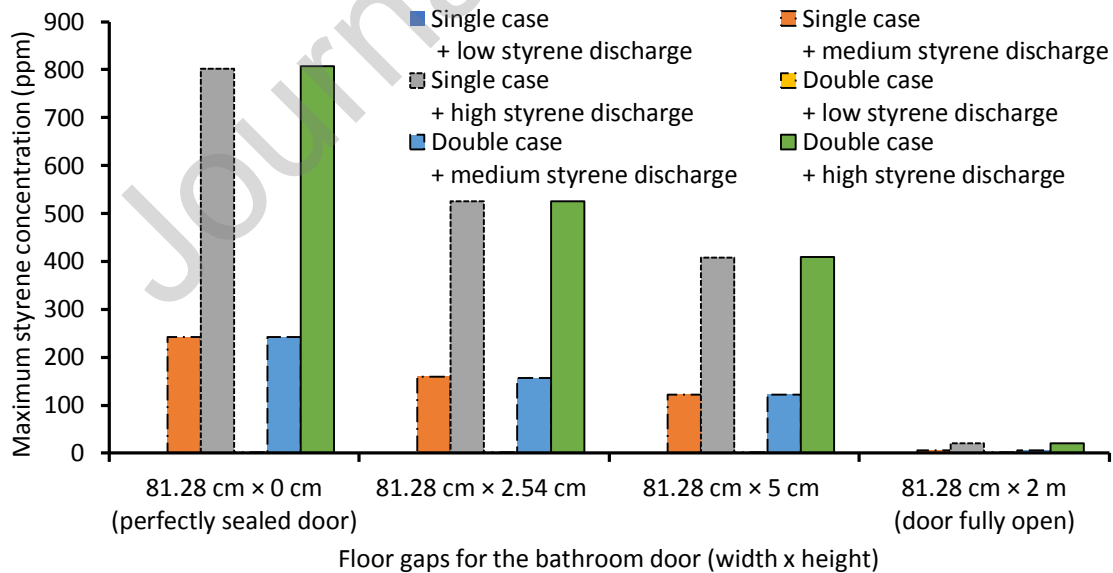
Figure 5. Maximum styrene concentrations for each bathroom door ELA condition for the: (A) instantaneous emission cases and (B) constant emission cases.
